BRIDGES

Dehumidification of bridges and affixed constructions

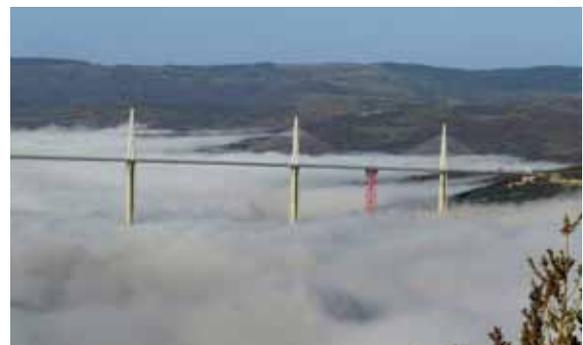
The impressive Millau Bridge in the southern part of France (picture up to the right) is dehumidified by several DST-dehumidifiers. The 2 kilometres plus long bridge is the connection on the A75 motorway between Bezier and Clermont-Ferrand.

Several DST-dehumidifiers have been installed on the bridge inside beneath the roadbed. The dry air spreads out through a channel system.

Eiffage (the company standing behind the bridge construction) guarantees that the bridge will have a service life of 120 years. One of the measures taken in order to keep up with that guarantee is the dehumidification of the bridge's inner parts as protection against corrosion.

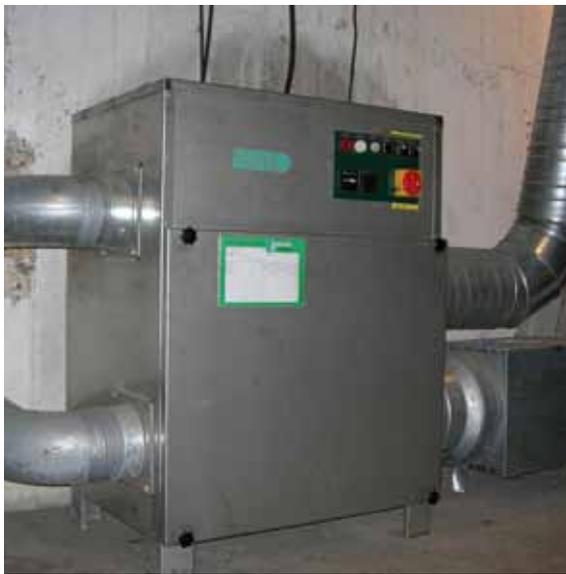
R-061R unit from Seibu Giken DST, installed in Liljeholmen bridge.

An air dehumidifier reduces the relative humidity to the desired level. If the relative humidity is lower than about 50% RH, steel and iron will not rust. The moisture is the villain of the piece, and that is what is removed.

A decision was made to start off with a trial installation. A DST dehumidifier was installed in one of the bridges, and the relative humidity was then logged carefully. The result was positive: the relative moisture level fell, and another DST dehumidifier was installed in the other bridge.

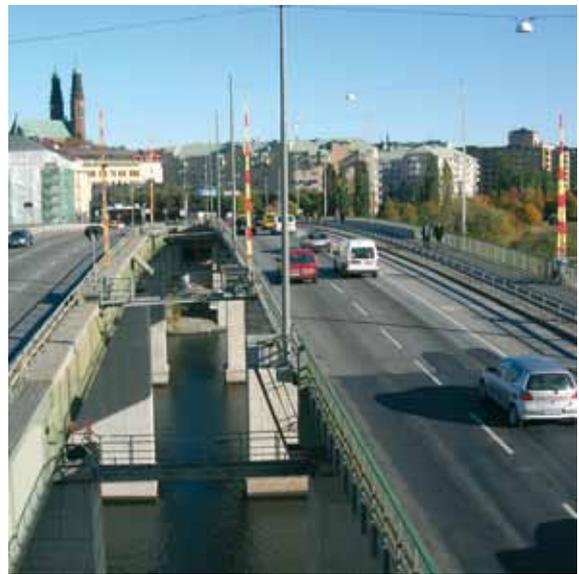
Traffic over the Liljeholmen bridge in southern Stockholm, looking towards Söder. The bridges are kept in good condition by two DST dehumidifiers.
